PK-USA PKI Series I-joists

Grouped Holes larger than 1-1/2" - Analysis

How to analyze holes cut too close together

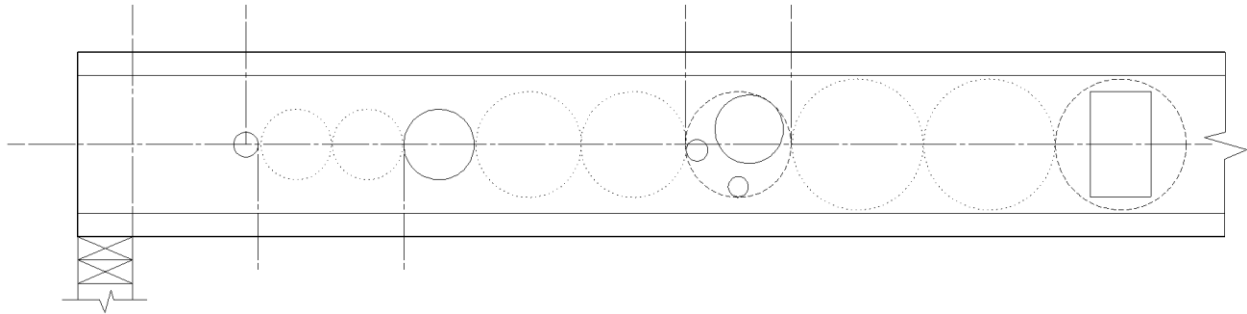
The allowance of multiple field cut holes in PKI Series I-joists is known and guidelines are published in both the specifiers guide, the installation guide, and in the current code evaluation report. The approved allowance of 2 times the greater dimension of the largest hole is as shown below:

For clustered round holes, as shown above, the circumscribed larger encompassing method can assist in evaluating if the theoretical “larger hole” is still allowed within a given location. Circumscribed rectangular or polygonal holes may also be allowed provided they fall within the allowable location of the theoretical “larger hole”.

For analyzing hole allowances for grouped circumscribed holes, rectangular holes, and holes in joists with unique loading conditions, both CSD® (Calculated Structural Design) software and Sapphire® by MiTek utilize the published web shear capacity of the PKI Series I-joist listed in the code evaluation report. When properly analyzed, if the hole or circumscribed larger hole “passes” the web shear check, the actual web hole condition does not need to be repaired or reinforced.

Holes greater than 1-1/2-inch in diameter and which fall outside of the above listed guidelines may need to be reviewed by a licensed design professional prior to acceptance by PK-USA.
